Feasibility/Alternatives Analysis Report Montgomery Dam, Megunticook River Camden, ME

May 3, 2019

Town of Camden,
Maine

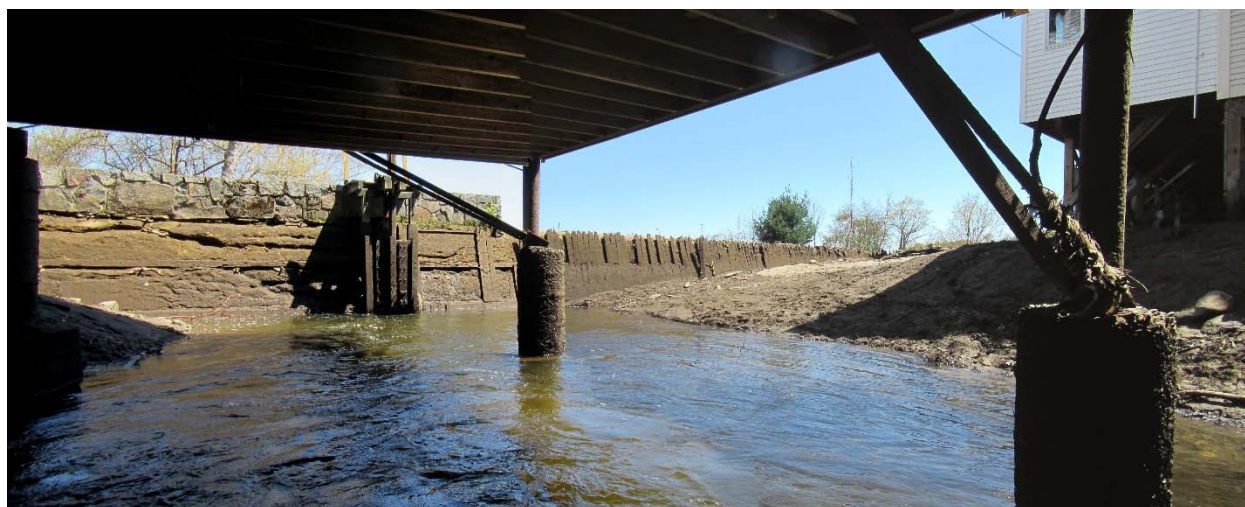
Figure 21. View of lower impoundment in drawn down condition, May 8, 2018. Non-overflow portion of dam and headgate at left half of image, spillway at right half of image. Normal pool elevation at spillway crest.

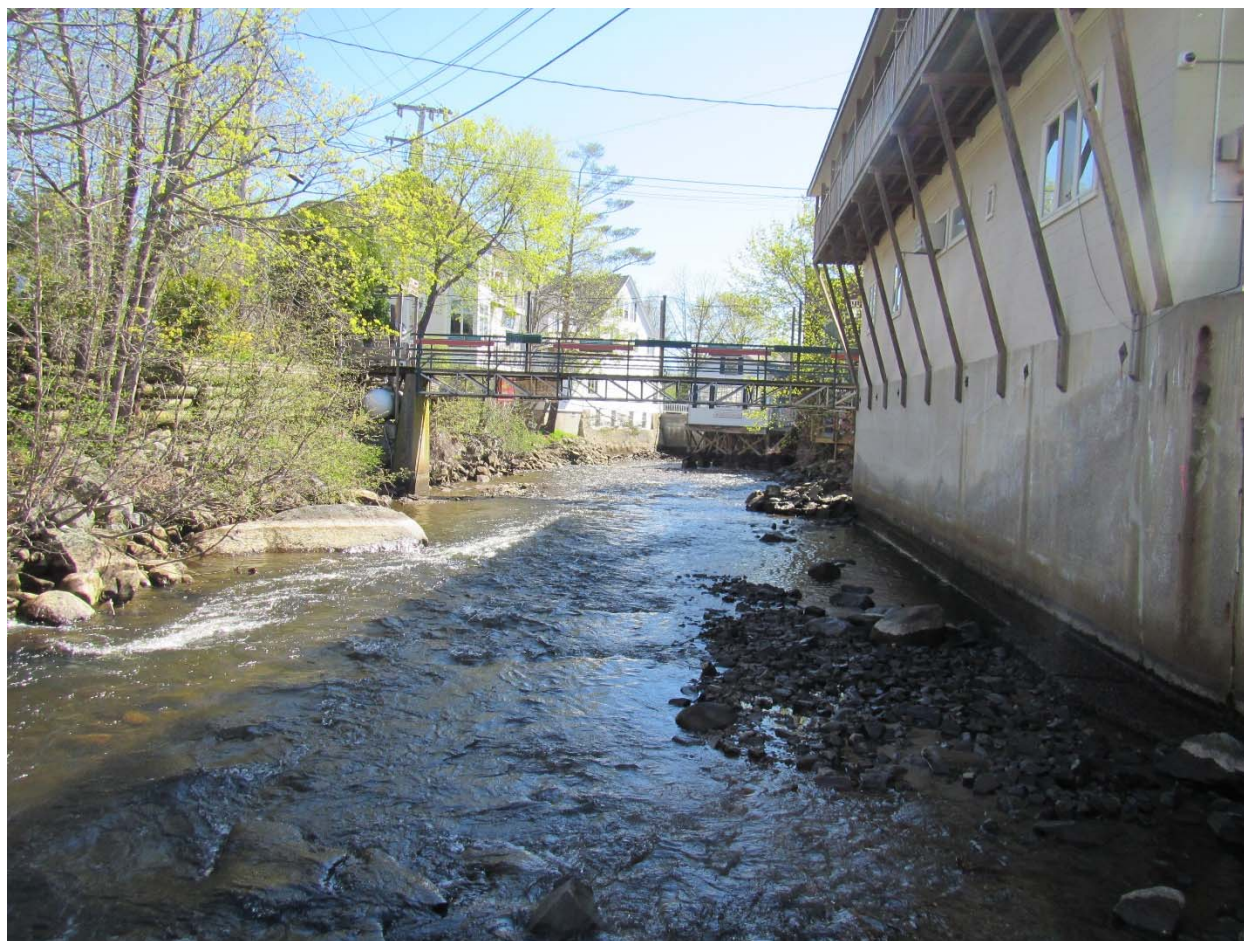
Figure 22. View of upper impoundment looking downstream from Brewster building in drawn down condition, May 8, 2018. Stain lines on large boulder at left, and concrete wall at right indicate normal pool elevation. The ground to the left of the channel is comprised of urban fill.

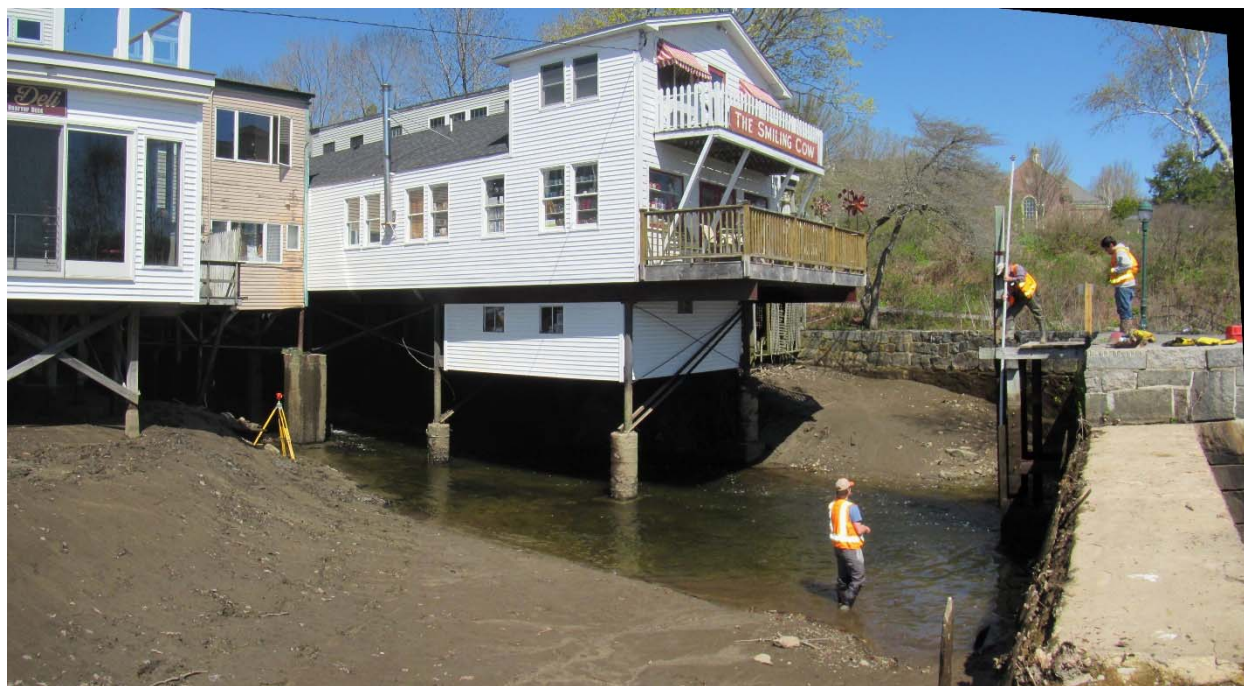
Figure 24. View of lower impoundment and north end of spillway in drawn down condition, May 8, 2018. Relict tank is located in the vicinity of the survey tripod at the left of the image.

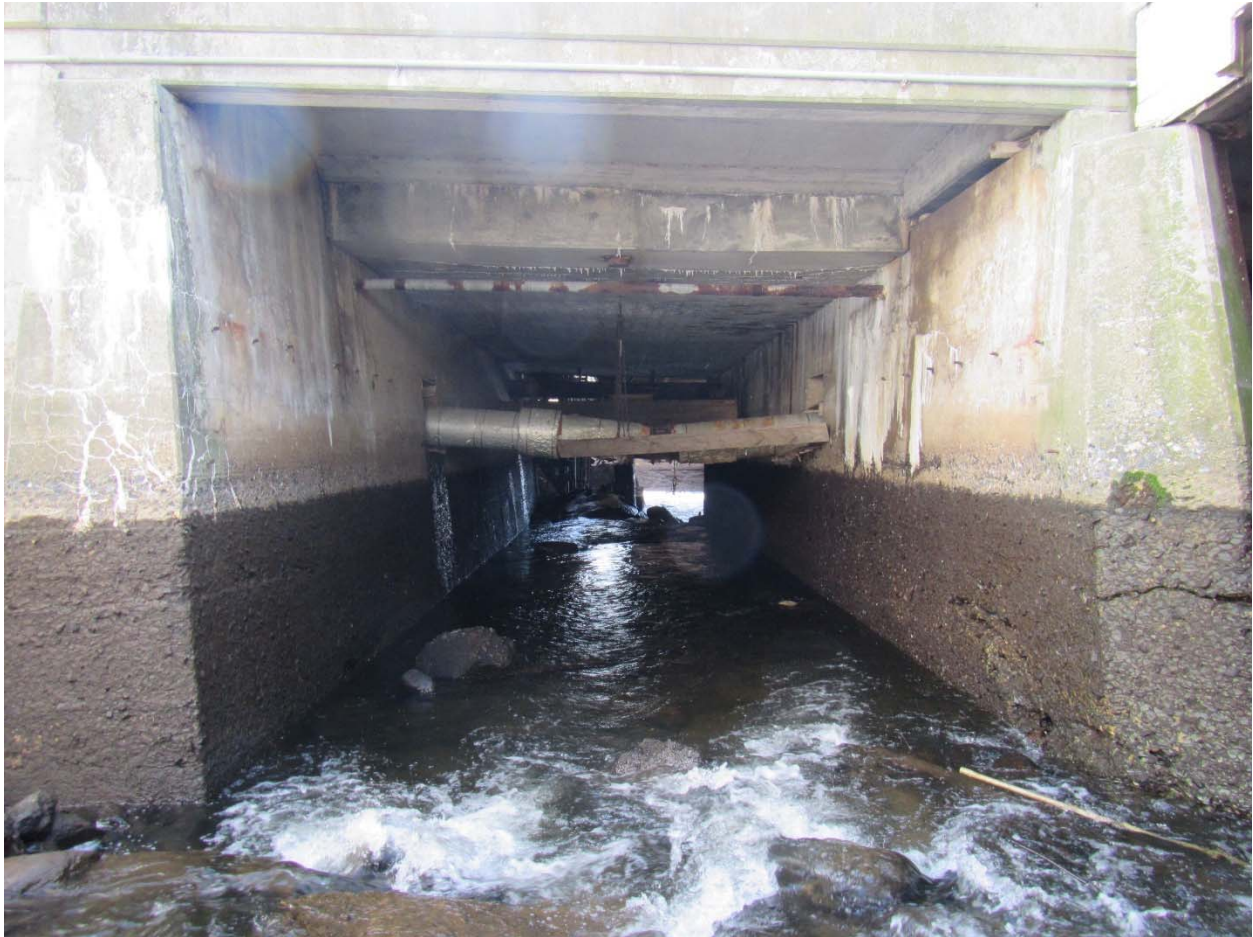
Figure 25. View downstream through north span of Main Street bridge in drawn down condition, May 8, 2018. Stain lines indicate normal pool elevation.

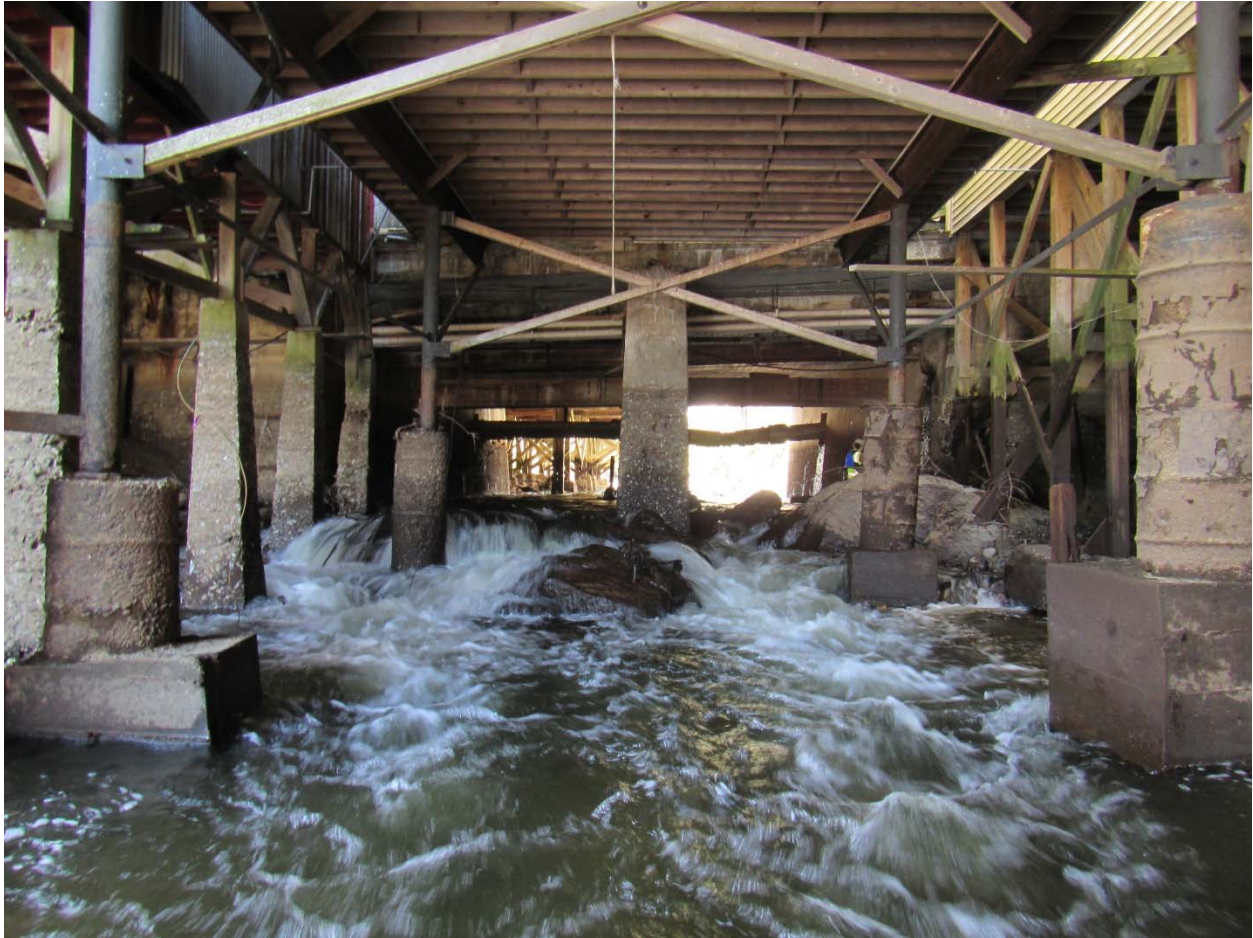
Figure 26. View upstream at Main Street bridge in drawn down condition, May 8, 2018. Hydraulic drop at downstream bridge opening in center of photo. Stain lines apparent on posts indicate normal pool elevation.

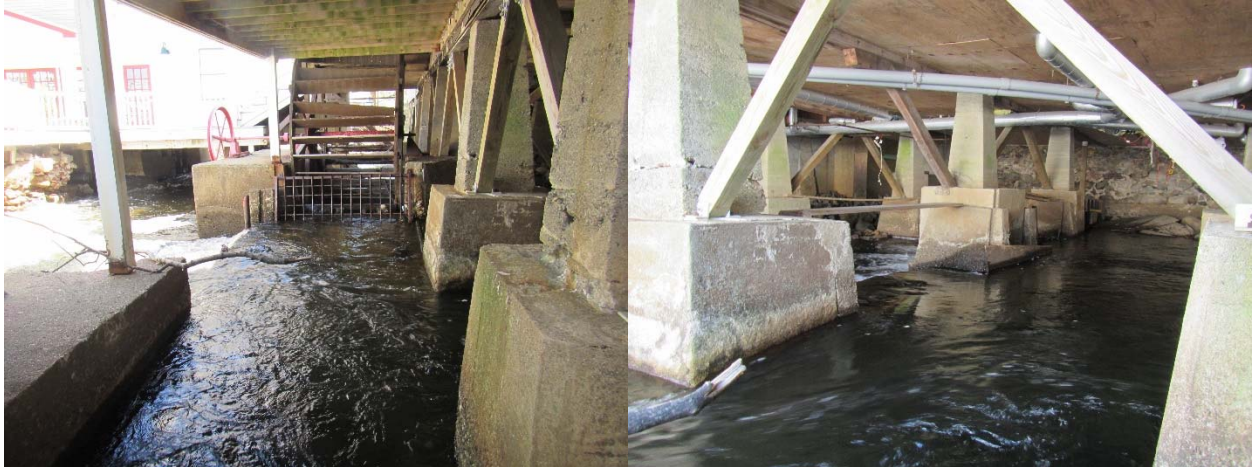
Figure 28. Looking downstream beneath Brewster building, May 8, 2018. Relict water wheels and weirs between pier footings visible in images.

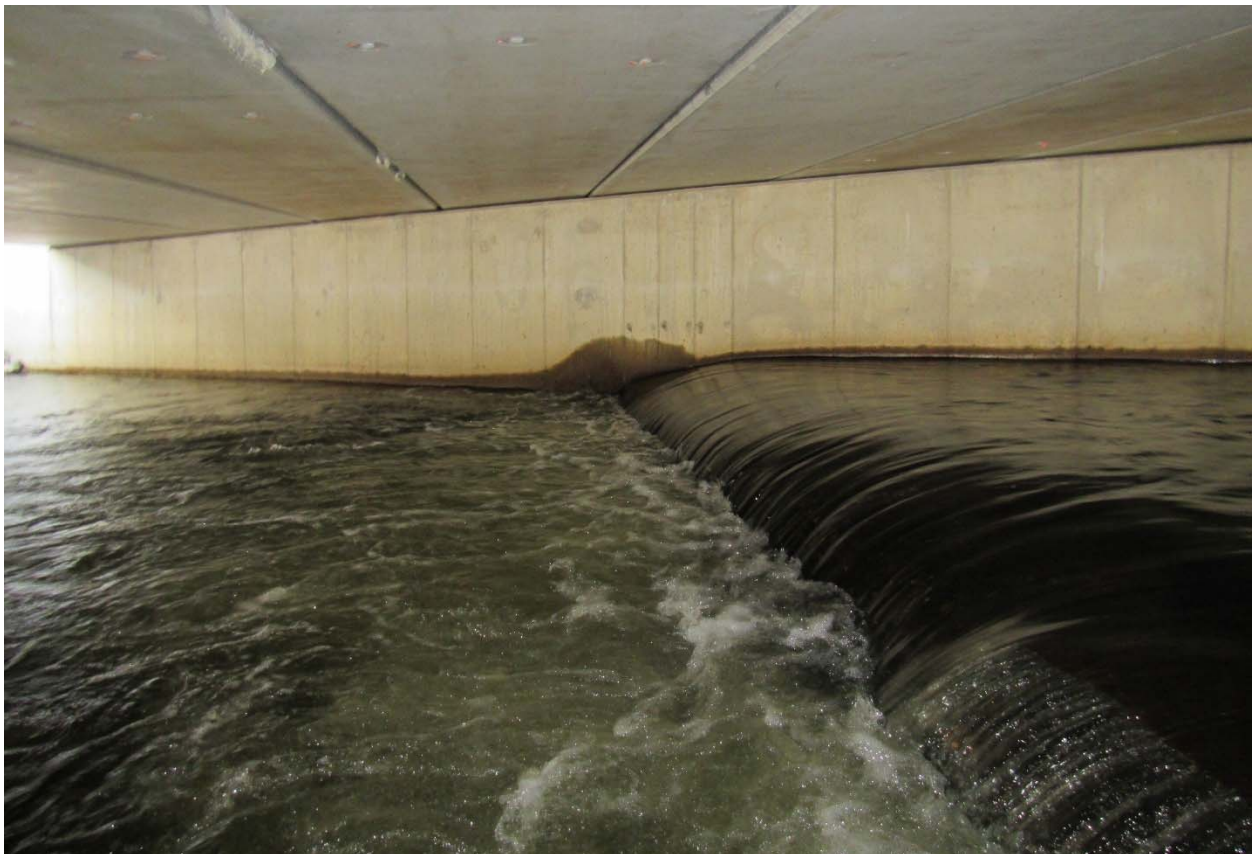
Lastly, the river flows under the Washington Street ('Bakery') Bridge (MDOT# 2981) approximately 500 feet upstream of Main Street. The super structure of the clearspan bridge was replaced in 2017. Beneath the bridge, a concrete-encased sewer pipe creates an approximate 9 inch to 12 inch hydraulic drop, which was also not assessed to be a full fish passage barrier (Figure 29).

Figure 29. View across channel beneath Washington Street bridge, May 8, 2018. Concrete sewer line encasement creates hydraulic drop of approximately 9 inches.

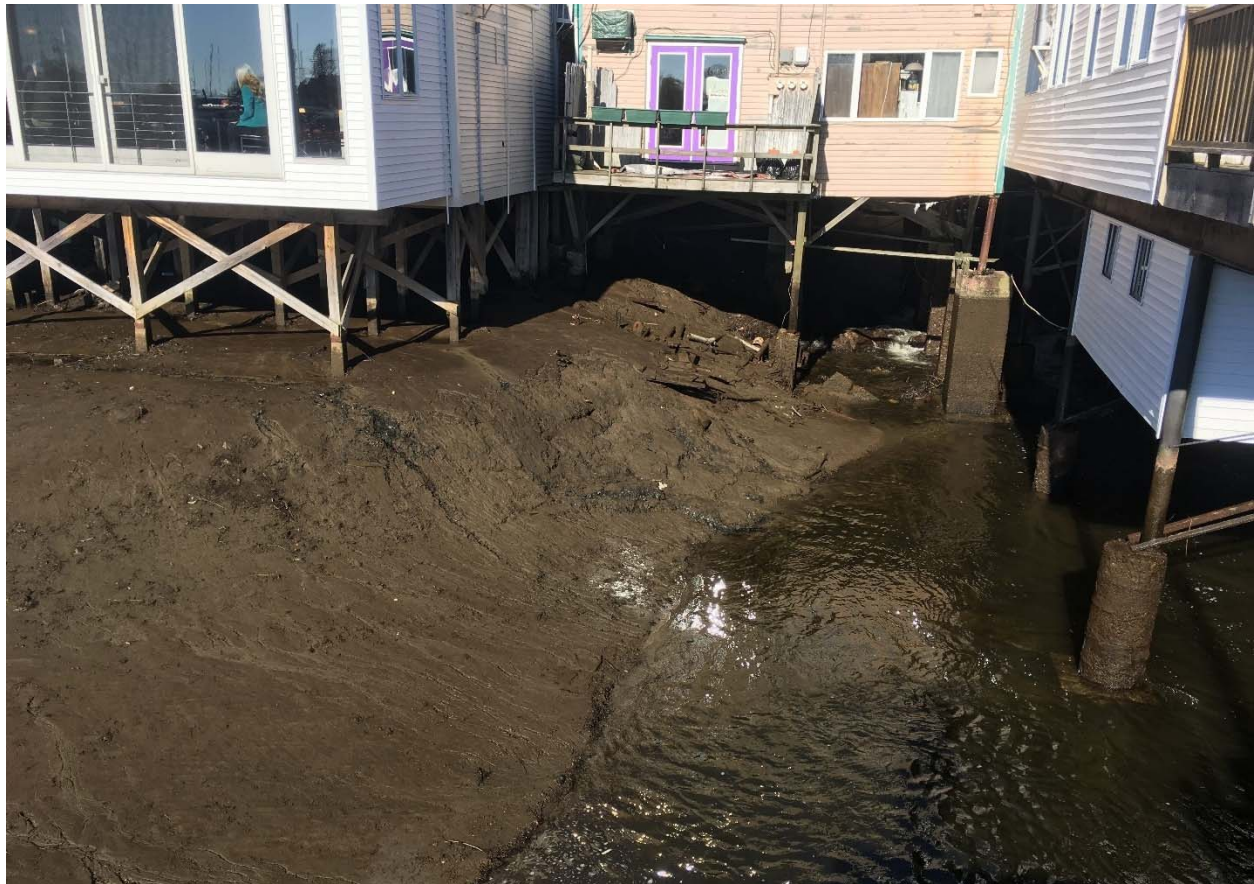
Figure 30. The impoundment with the water level drawn down. A modest volume of fine-grained sediment is trapped behind the dam. May 8, 2018. Relict tank location is immediately below and several feet downstream of the purple French doors in the image.

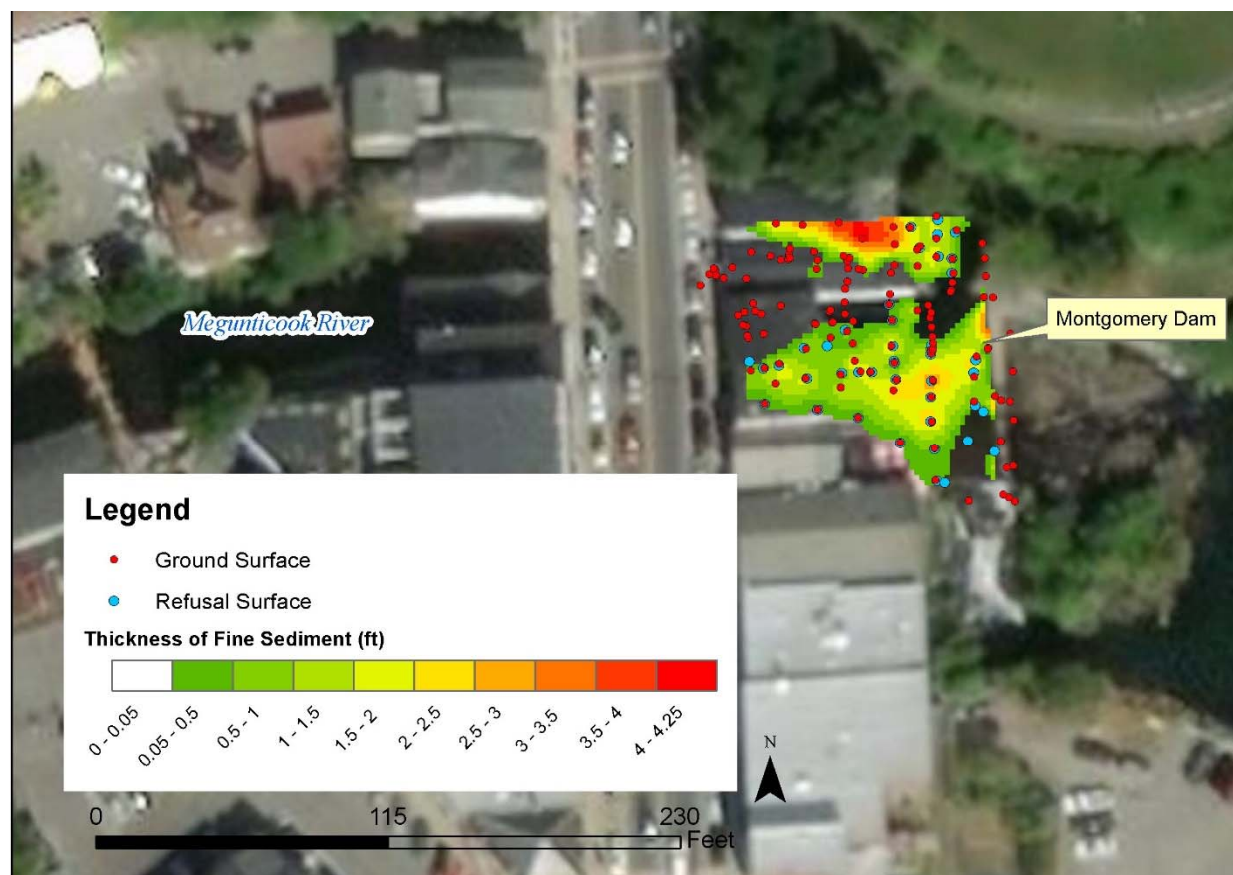
Figure 31. Estimated thickness of fine sediment trapped behind the dam.
