# Town of Camden, Maine Camden Municipal Building Retro-Commissioning Interim Report

March 28, 2011

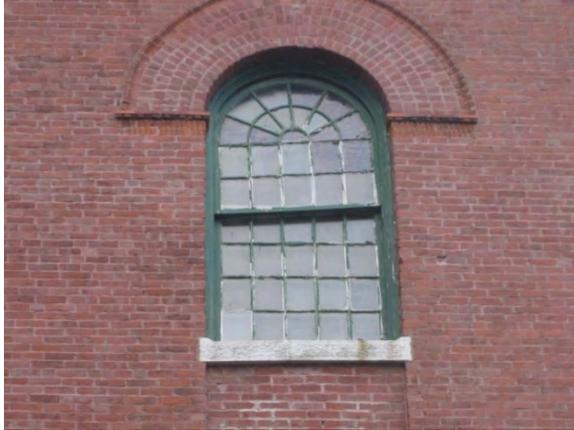
- Windows have come off their tracks and are allowing outside air to infiltrate
- Openings through the exterior envelope are not sealed and are allowing outside air to infiltrate

Exterior Window

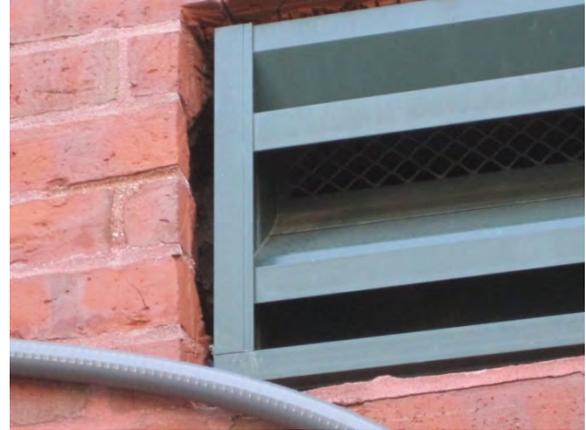
Outside Air Intake Louver

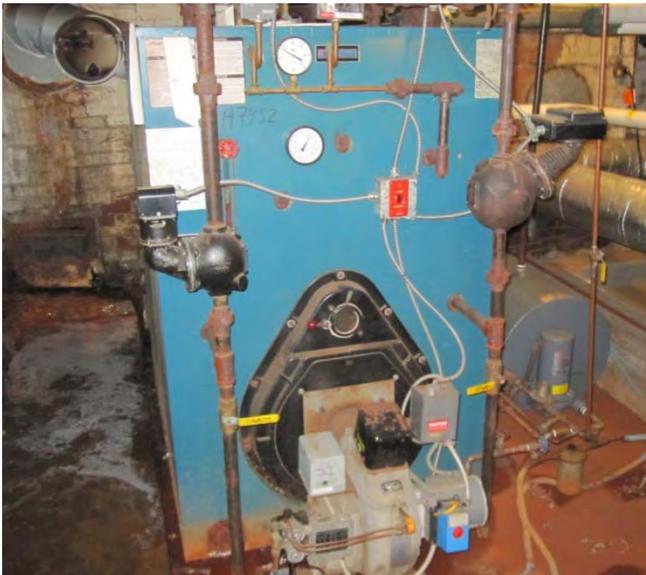
Observation: The existing 1,519 MBH Burnham oil fired steam boiler was installed in approximately 1999 and might be the second or third boiler to operate in this building. The steam boiler has an older HB Smith Carlin burner. There are three 330 gallon fuel tanks in Basement No. 1 next to the boiler and a relatively new condensate tank and make-up feed pump. The combustion air supply is uncontrolled and allows cool air to pass through the burner, thereby reducing the efficiency of the boiler. The boiler appears to be maintained and operating at approximately 83% efficiency. There is no chemical water treatment on the boiler which would eliminate scaling on the water side of the boiler. With an effective steam trap maintenance program and a good condensate return system, the make-up water could be kept to a minimum thus reducing the need to treat make-up water.

Steam Boiler

Recommendations: It is recommended that a combustion air damper with an actuator be installed to only allow outside air into the boiler room when the boiler is firing. Studies have shown that air flow through idle boilers can reduce boiler efficiency by 1.5%.

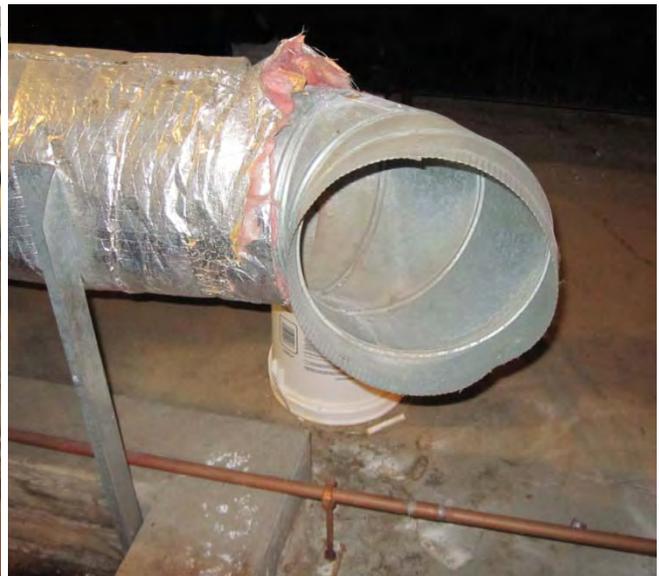
Boiler Combustion Air Supply

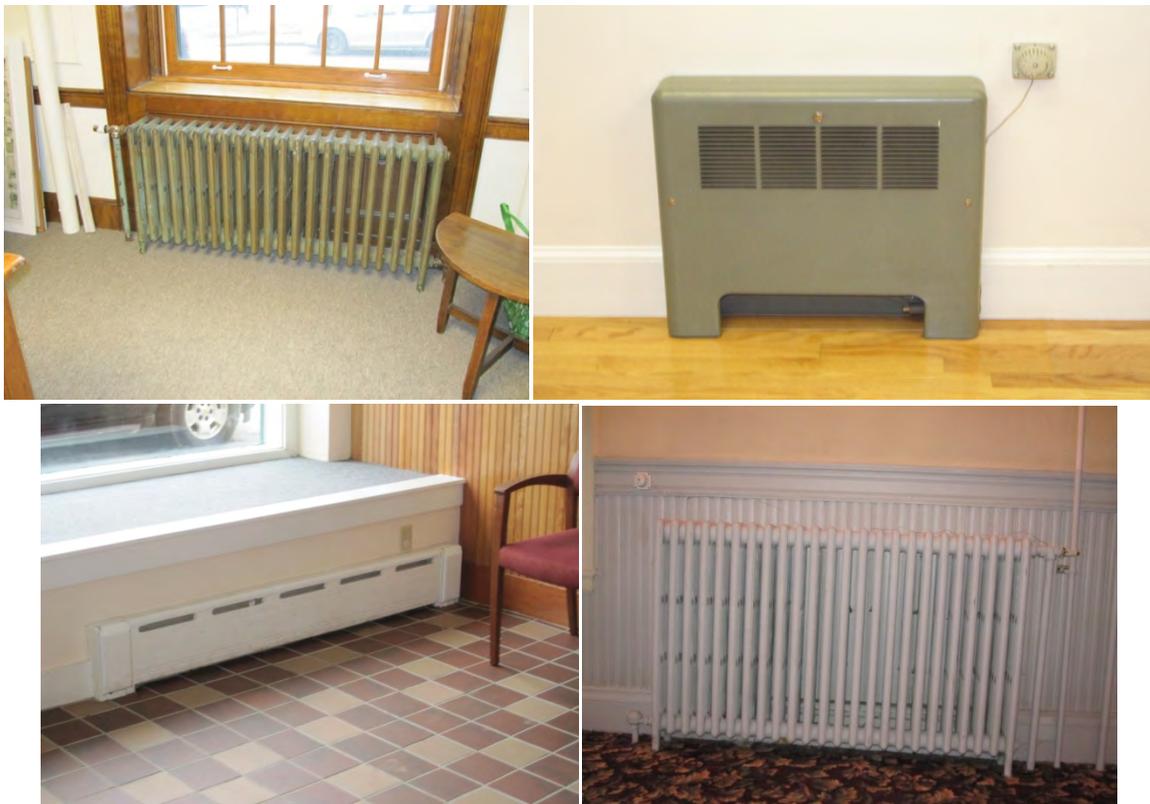
**Observation:** There are a total of ten steam zones throughout the building that have been modified over the years creating multi-floor zoning and multiple zones within the same area. We have identified and documented all of the zones. All the radiators and baseboard units have been accounted for within the ten zones. The zone control valves vary in age, some as far back as the 1960s. All the zone valves are controlled by Honeywell T-87 analog thermostats except for the thermostat in the assessor's office and meeting room. There are multiple style heating devices, radiators, baseboard, and wall units. Most of the original steam radiators have been modified with a manual control supply valve allowing for individual control of each unit within a particular zone. This is true for the fin tube style wall mounted units typical in the Town Manager's Office. The cast iron baseboard that is used in several zones allows steam to pass straight through without this type of device. There are a number of radiators that appear to be originally designed for a hydronic (water) heating system. They have been installed in several locations and are not as effective to operate as a steam radiator.

Various Steam Radiator Heating Unit Styles

**Recommendations:** The zone control throughout the building should be modified to manage the individual spaces and individual floors. Multiple thermostats in the same space should be combined into one thermostat to control the heating and cooling specifically in the Finance area and the Main Town Office area. We recommend installing modulating programmable thermostats in occupied spaces.

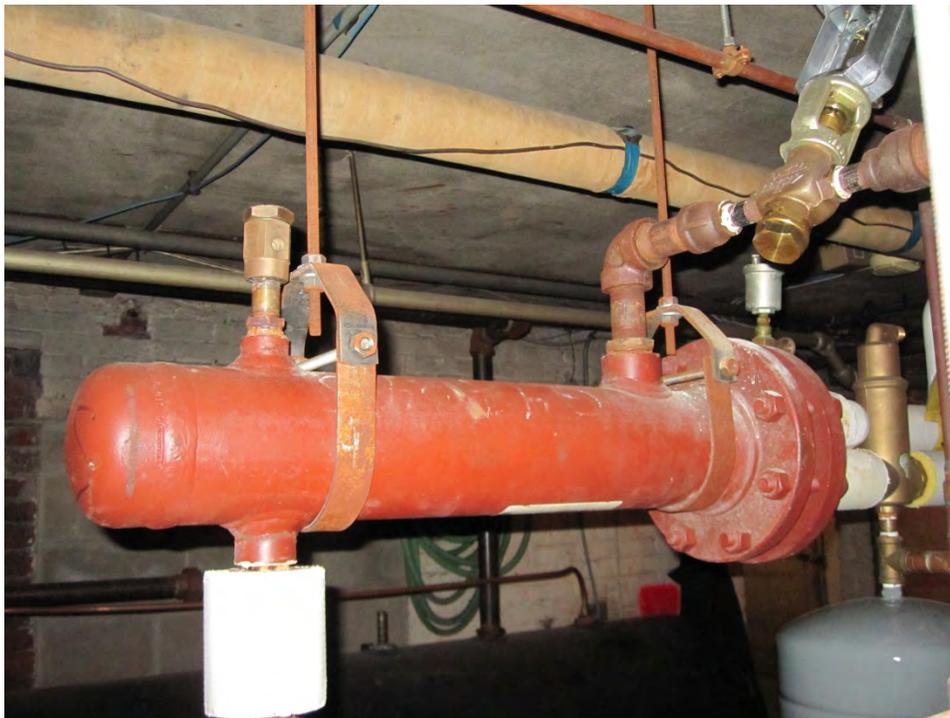
Observation: In the basement there is a small TACO steam to water heat exchanger used for two of the four air handlers with reheat coils in the Main Town Office area and the Finance area. This unit has a dedicated circulation pump that is controlled by outside air and the water loop temperature control is set up to operate on outside air. The outside air set points were backward and have been corrected. Outside air reset works on this principle: the colder the ambient air, the hotter the water needs to be when supplied to the coils. The boiler temperature was set on 170°F when outside air was 70°F, and 70°F when the outside air was 20°F. As a result, this was forcing the control to operate the heat exchanger at 170°F all the time. A fourth air handler is located in the Tax Assessor area that has a steam coil for heat.

Steam to Water Heat Exchanger

Recommendations: We corrected the heat exchanger set points to operate at 170°F when the outside air is 0°F and 112°F when the outside air is 60°F. The Honeywell T775R controller immediately responded and reset the loop temperature to 138°F on a 40°F day.

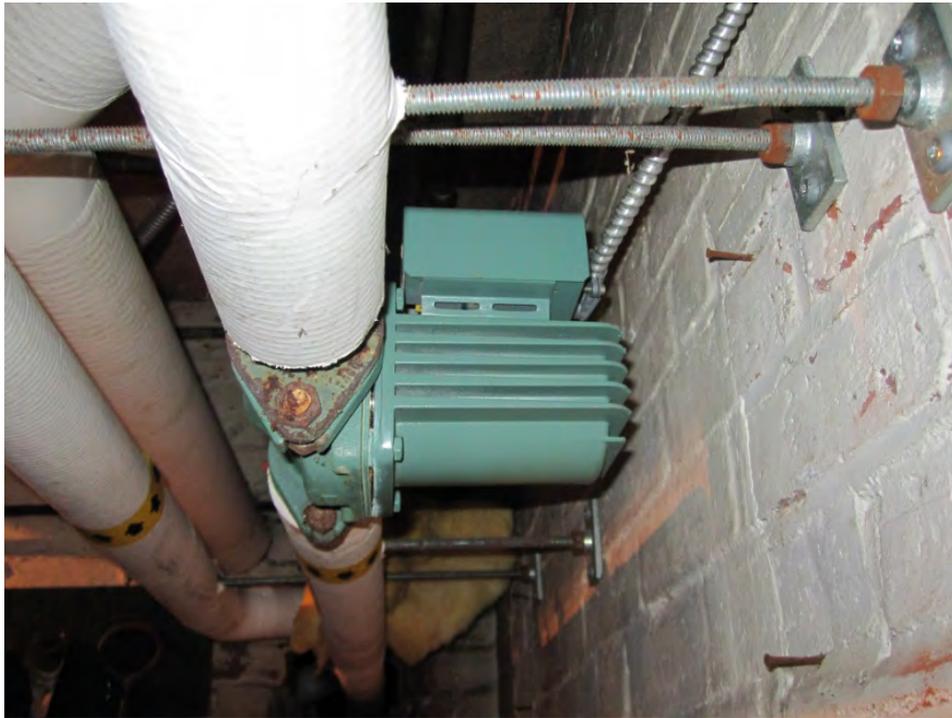
Observation: The TACO hot water circulation pump is dedicated to the two air handlers that serve the Main Town Office area and the Finance area. This pump is also controlled by outside air and is currently set on 38°F. There is no control connection between the pump and the heat exchanger.

Hot Water Circulation Pump

Recommendations: We recommend controlling the pump with the existing heat exchanger controller. These two components should be operating in sequence.

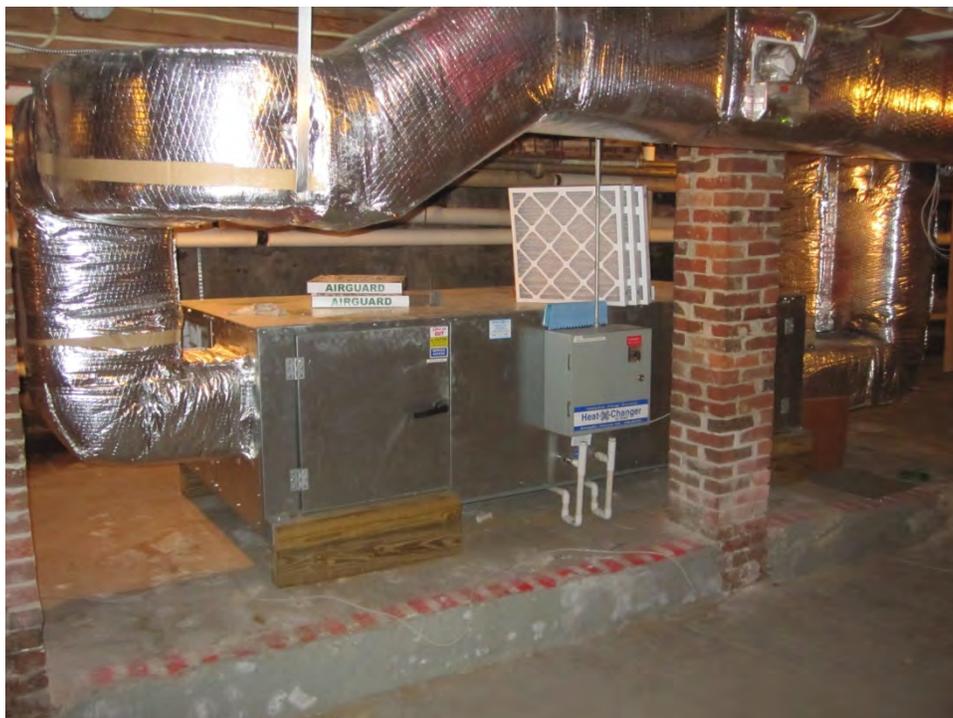
Observation: HRV-1 is located in Basement No. 2 and is controlled by a Honeywell controller in Basement No. 1. The HRV unit was installed to perform two functions:

The unit does not have any heating capabilities other than through the exchange of air. There is a defrost cycle available on the unit that is not being used based on the location of the unit and the supply air being exhausted.

The unit is controlled by a Honeywell T775E controller which is based on outside air humidity. The set point is set at 95% with a 1% humidity differential. This means when the humidity level rises above 95%, the unit will start and when the humidity level drops below 94%, the unit will shutdown. These numbers may be set higher for the winter months to ensure the unit does not run.

We are concerned about the controls for this unit because the unit is designed to recover exhaust heat from the basement and remove humidity in the summer which, in turn, cools the incoming air for the ventilation to the air handlers. The controller is not connected to the air handlers, therefore the unit will run on its own controls without knowing the status of the air handlers. During our on-site visits, the air handlers were off for the most part and the air to air heat exchanger was running and supplying air that was not being delivered anywhere.

Air to Air Heat Exchanger

Recommendations: We recommend connecting the operation of the air to air heat exchanger to the Main Town Office Air Handler No. 3. This will operate the unit only when the building is occupied during the day which is when humidity levels are highest. This will reduce the electrical consumption on this unit by 14 hours per day.

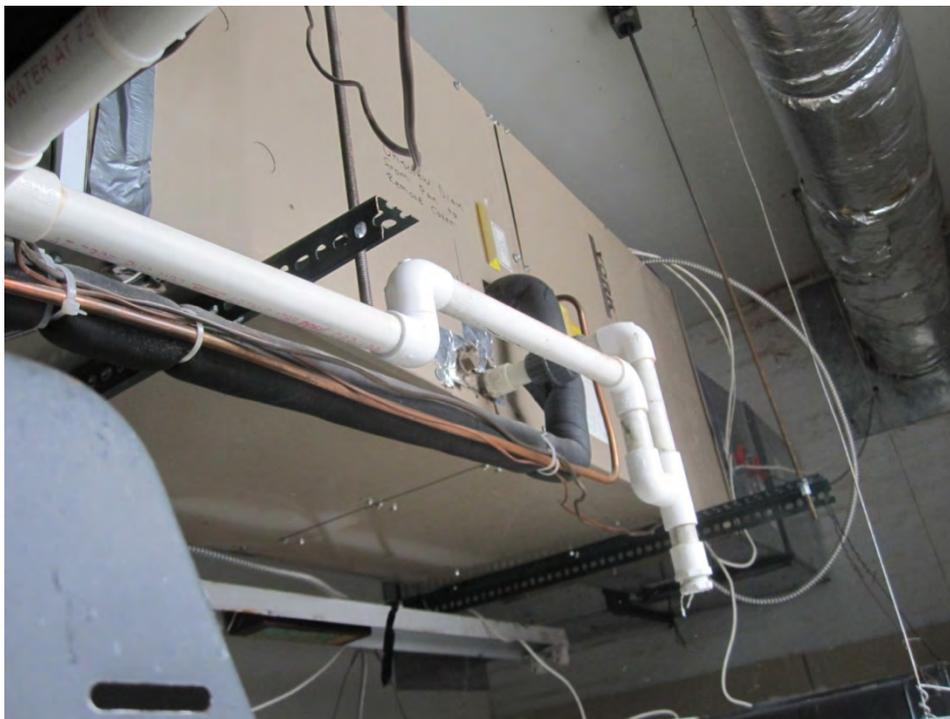
Observation: This unit is a 5 ton York air conditioning unit that is supplied with outside air through the air to air heat exchanger in the basement. This unit is controlled by a programmable thermostat and a Honeywell T775 R controller. The thermostat also controls the fin tube radiation in this area. The unit was not operating at the time of our on-site inspection and we noted the set points for heating and cooling at 66°F and 77°F respectively. The schedule was the same Sunday through Saturday 6:00 a.m. to 9:00 p.m. We are planning to return in order to measure the electrical demand once the air conditioning season starts.

Air Handler No. 1

Recommendations: We recommend that the timeframes be reviewed and adjusted to meet the needs of the space as well as changing unoccupied set points to minimize the run time of the equipment during off hours.

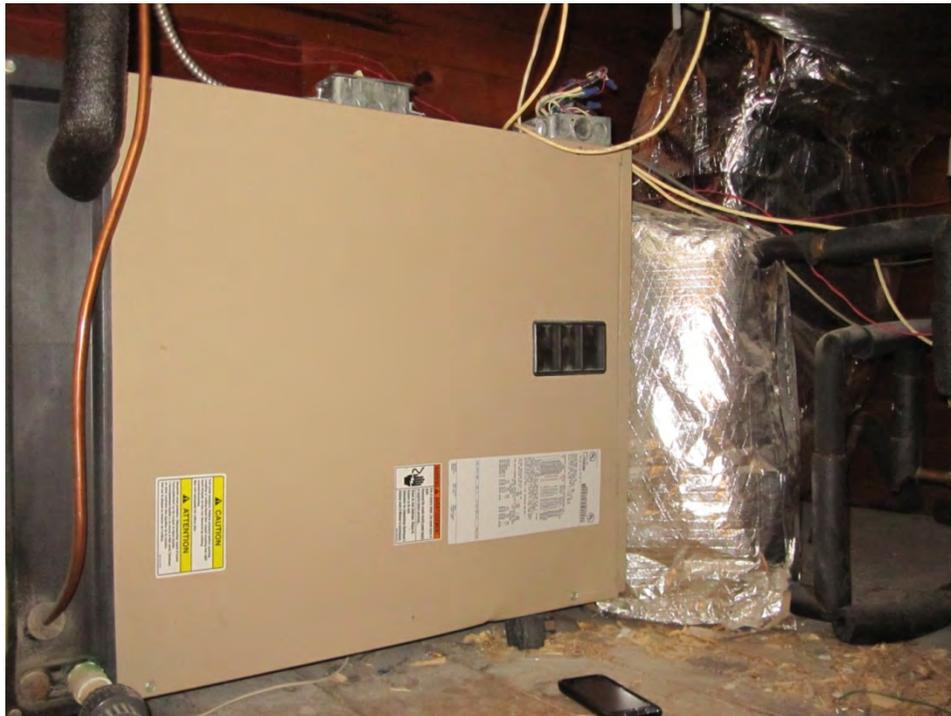
Observation: This unit is a York 3.5 ton air conditioning unit located above the bathroom ceiling on the back side of the Finance area. The unit is controlled by a programmable thermostat that controls the set points and schedule. The area of the building that this unit serves also has a heating thermostat that controls baseboard units and radiators. This heating thermostat also controls heating units in other parts of the building. The Honeywell controller in the basement was originally set up to control the heating of the space in two stages. This was changed at some point and the standalone thermostat in the Finance area was installed. The controller now only controls the discharge air set point when the programmable thermostat is calling for heat. The thermostat controls the unit when cooling is needed as well as the on and off schedule. We noted the set points for heating and cooling at 65°F and 76°F respectively. The schedule was Monday through Friday 6:30 a.m. to 6:00 p.m. with an unoccupied set point of 55°F heating and 80°F cooling. The unit is scheduled off Saturday and Sunday. We are planning to return in order to measure the electrical demand once the air conditioning season starts.

Air Handler No. 2

Recommendations: We recommend that the two systems be controlled by one modulating thermostat if the other heating considerations in this report are implemented.

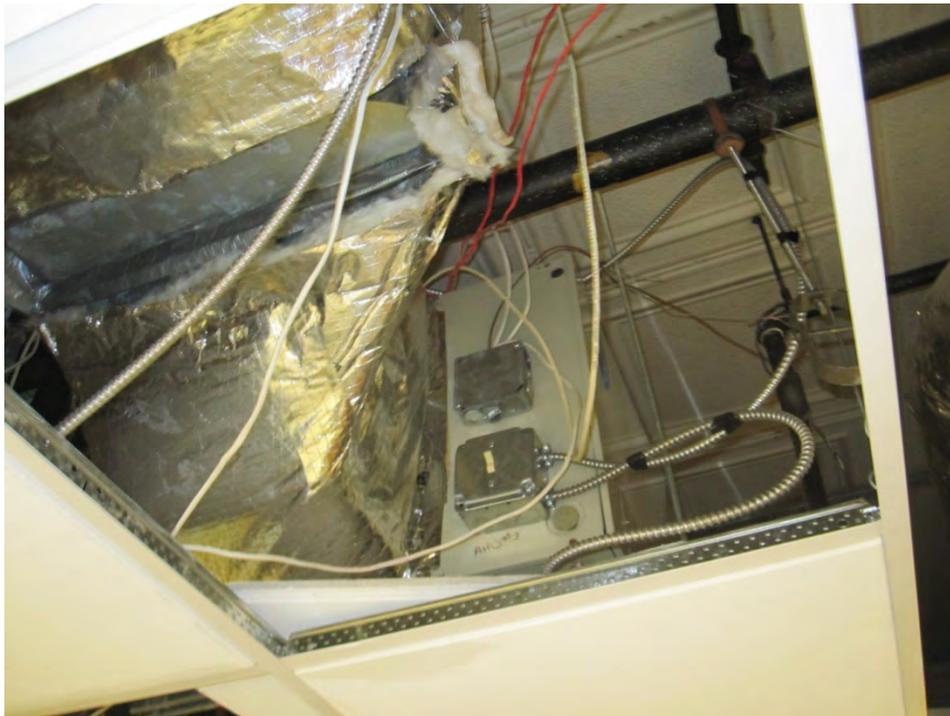
Observation: This unit is a 5 ton York air conditioning unit that is supplied with outside air through the air to air heat exchanger in the basement. The unit is controlled by a programmable thermostat and a Honeywell T775 R controller. The Honeywell controller in the basement was originally set up to control the heating of the space in two stages. The area of the building this unit serves also has a heating thermostat that controls baseboard units and radiators. The controller now only controls the discharge air set point when the programmable thermostat is calling for heat. The thermostat controls the unit when cooling is needed and the on/off schedule. The heating thermostat next to the air conditioning thermostat controls the baseboard in the Town Office area and some radiators on the second floor. The unit was not running at the time of our on-site inspection. We did turn the unit on to witness the unit through the sequence of operation. The thermostat was not controlling the unit and the reheat valve would not modulate. It is our understanding that the maintenance contractor is aware of this problem and going to make the necessary repairs. We noted the set points for heating and cooling at 65°F and 76°F respectively. The schedule was Monday through Friday 6:30 a.m. to 6:00 p.m. with an unoccupied set point of 55°F heating and 80°F cooling. The unit is scheduled off Saturday and Sunday. We are planning to return in order to measure the electrical demand once the air conditioning season starts.

Air Handler No. 3

Recommendations: We recommend that the two systems be controlled by one modulating thermostat if the other heating considerations in this report are implemented. The modulating heating valve also needs to be adjusted or replaced.

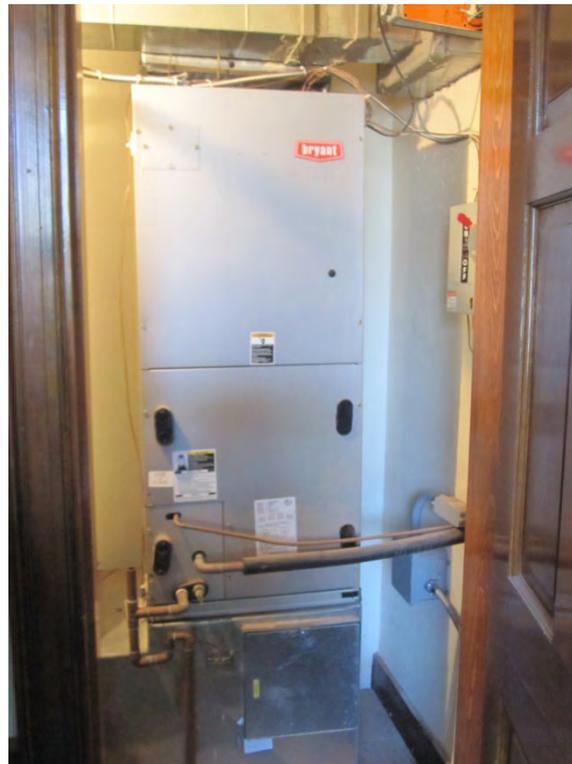
Observation: The 5 ton Bryant air conditioning unit has its own controller and a standalone thermostat. The thermostat was in the unoccupied mode, we assume for the winter months. This unit was originally installed to provide air conditioning and ventilation. This unit should be operating year round. The unit is equipped with an outside air damper that was not functioning during our on-site inspection and a steam coil to heat the discharge air. The steam control valve was functioning, but we did not measure any increase in temperature on the discharge air. The steam trap may need to be looked at because we did determine that the steam was available to the coil. We did not energize the condensing unit due to the time of year, however, we noted the set points for heating and cooling at 60°F and 75°F respectively. The schedule was Monday through Friday 8:00 a.m. to 4:30 p.m. with an unoccupied set point of 55°F heating and 80°F cooling. The unit is scheduled off Saturday and Sunday. We are planning on returning to measure the electrical demand once the air conditioning season starts. There are penetrations for the ductwork and wiring through the exterior wall that have not been sealed.

Air Handler No. 4

Consideration: We recommend replacing the outside actuator and consider running the air handler throughout the year for a few hours a day. Also investigate the steam coil to determine what is restricting the flow. The penetrations are address is Section 1.2, Other Considerations.

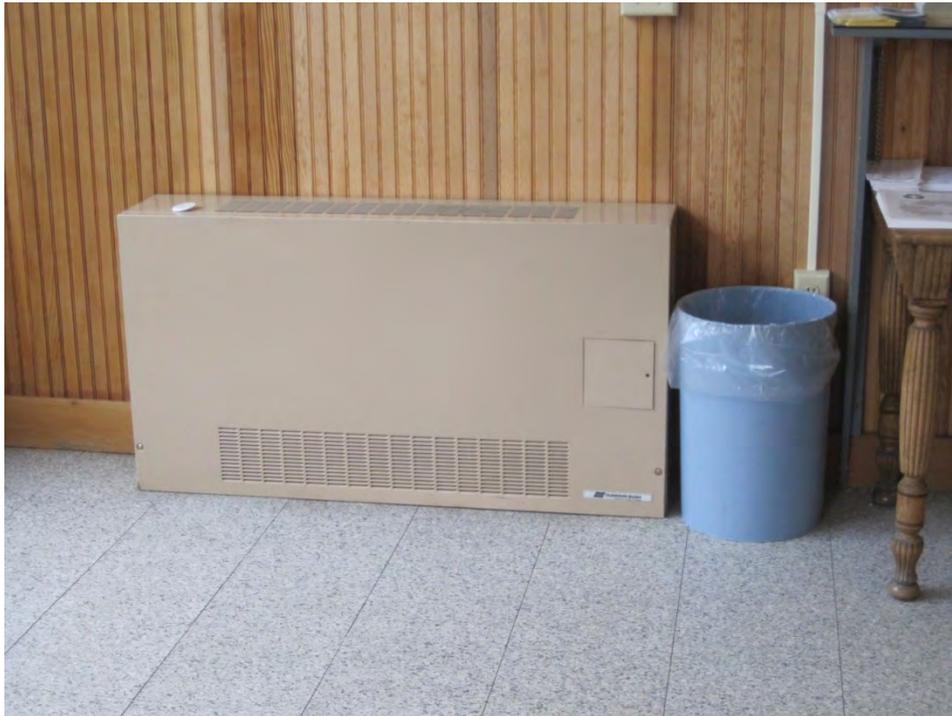
Observation: There is one cabinet unit heater in the lobby of the Finance area. The unit is supplied with steam for heat and is controlled locally by a manual speed control.

Cabinet Unit Heater

Recommendations: There is no recommendation at this time other to ensure the unit is secured during the summer months and that filters are changed on a regular schedule.

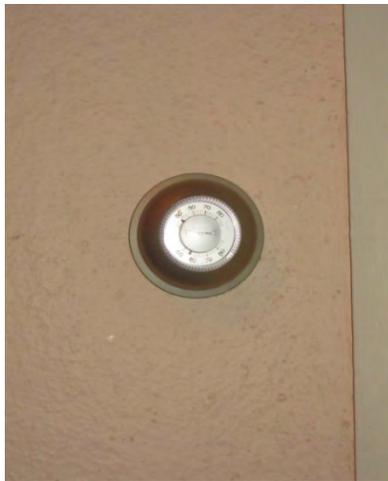
Observation: There are a number of thermostats in the building and, based on our on-site inspections, we understand from the staff that not everyone understands how they operate or what they operate. There are a number of Honeywell T-87 thermostats that do not have the capability of night setback.

Heating Thermostat

Recommendations: We recommend replacing all the thermostats with one style that has the same features to eliminate developing an understanding of multiple programmable thermostats. We also recommend installing programmable thermostats in place of any Honeywell T-87 thermostats that are occupied Monday through Friday.

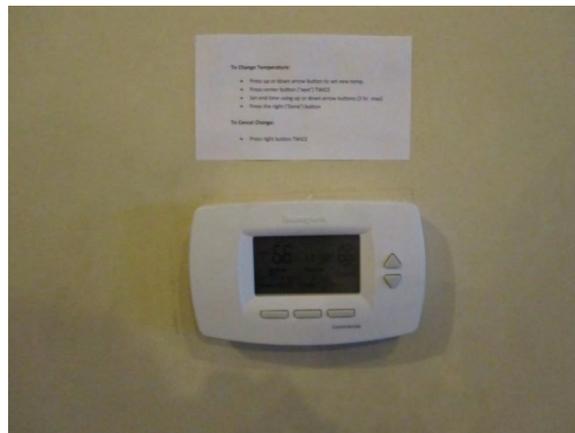
Cooling Thermostat

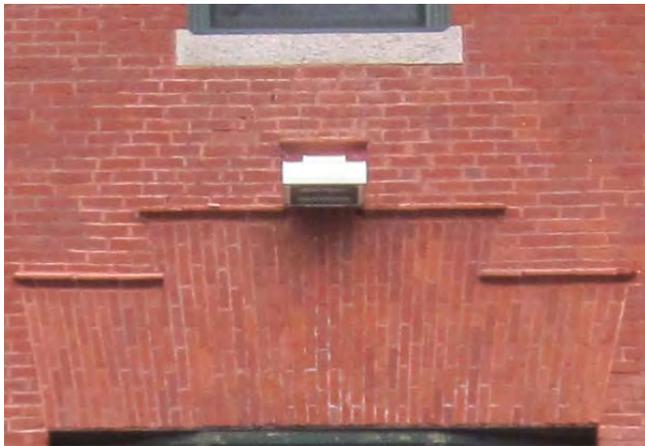
Observation: We observed the majority of the interior lighting to be either T-8 fluorescent fixtures or compact fluorescent bulbs. We did observe T-12 fluorescent fixtures in the basement and in unoccupied spaces. The chandeliers in the building all have incandescent candelabra bulbs. There are compact fluorescent bulbs available that fit this type of socket (if the Town of Camden is agreeable with this level of illumination and appearance of the chandelier). There are minimal exterior fixtures on the building. There are incandescent fixtures on the Washington Street side which are relatively low wattage and serve a specific purpose. There are three metal halide wall wash fixtures on the Elm Street side of the building. These fixtures are controlled by a time clock which is not in use. We assume that the lights are turned on when needed or during an event.

Exterior Lighting

Recommendations: We recommend replacing the T-12 fixtures over the next 6 months with energy efficient T-8 fixtures. Any remaining incandescent bulbs throughout the building should continue to be replaced with compact fluorescent bulbs as they expire. If the time clock is not going to be used, it should be removed.

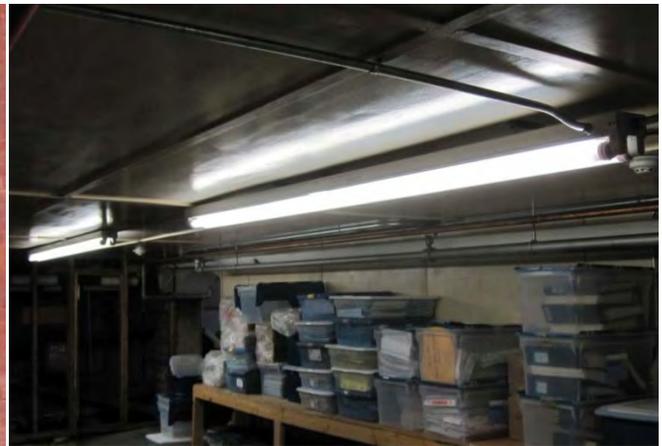
Interior T-12 Lighting

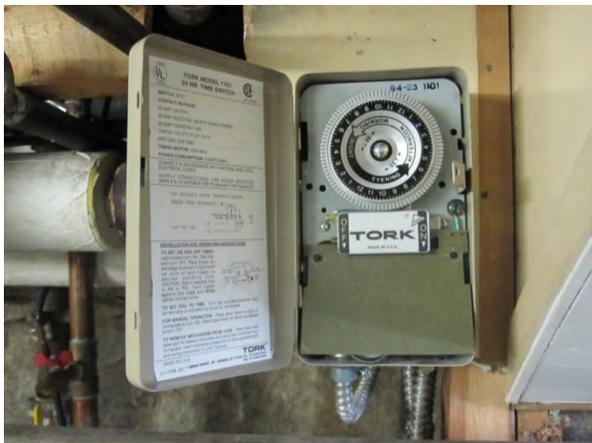
Exterior Lighting Timeclock

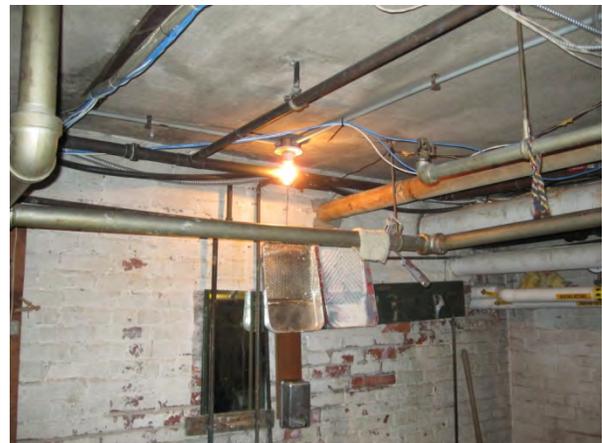
Interior Incandescent Lighting
