Memorandum

Project Name: Montgomery Dam Removal & Fish Passage Design

Task: Project Management
Memo Title: Project Scope - Grant Closeout Report
To: Audra Caler, Town Manager
Town of Camden Maine
From: Michael Burke
Date: 04/12/22

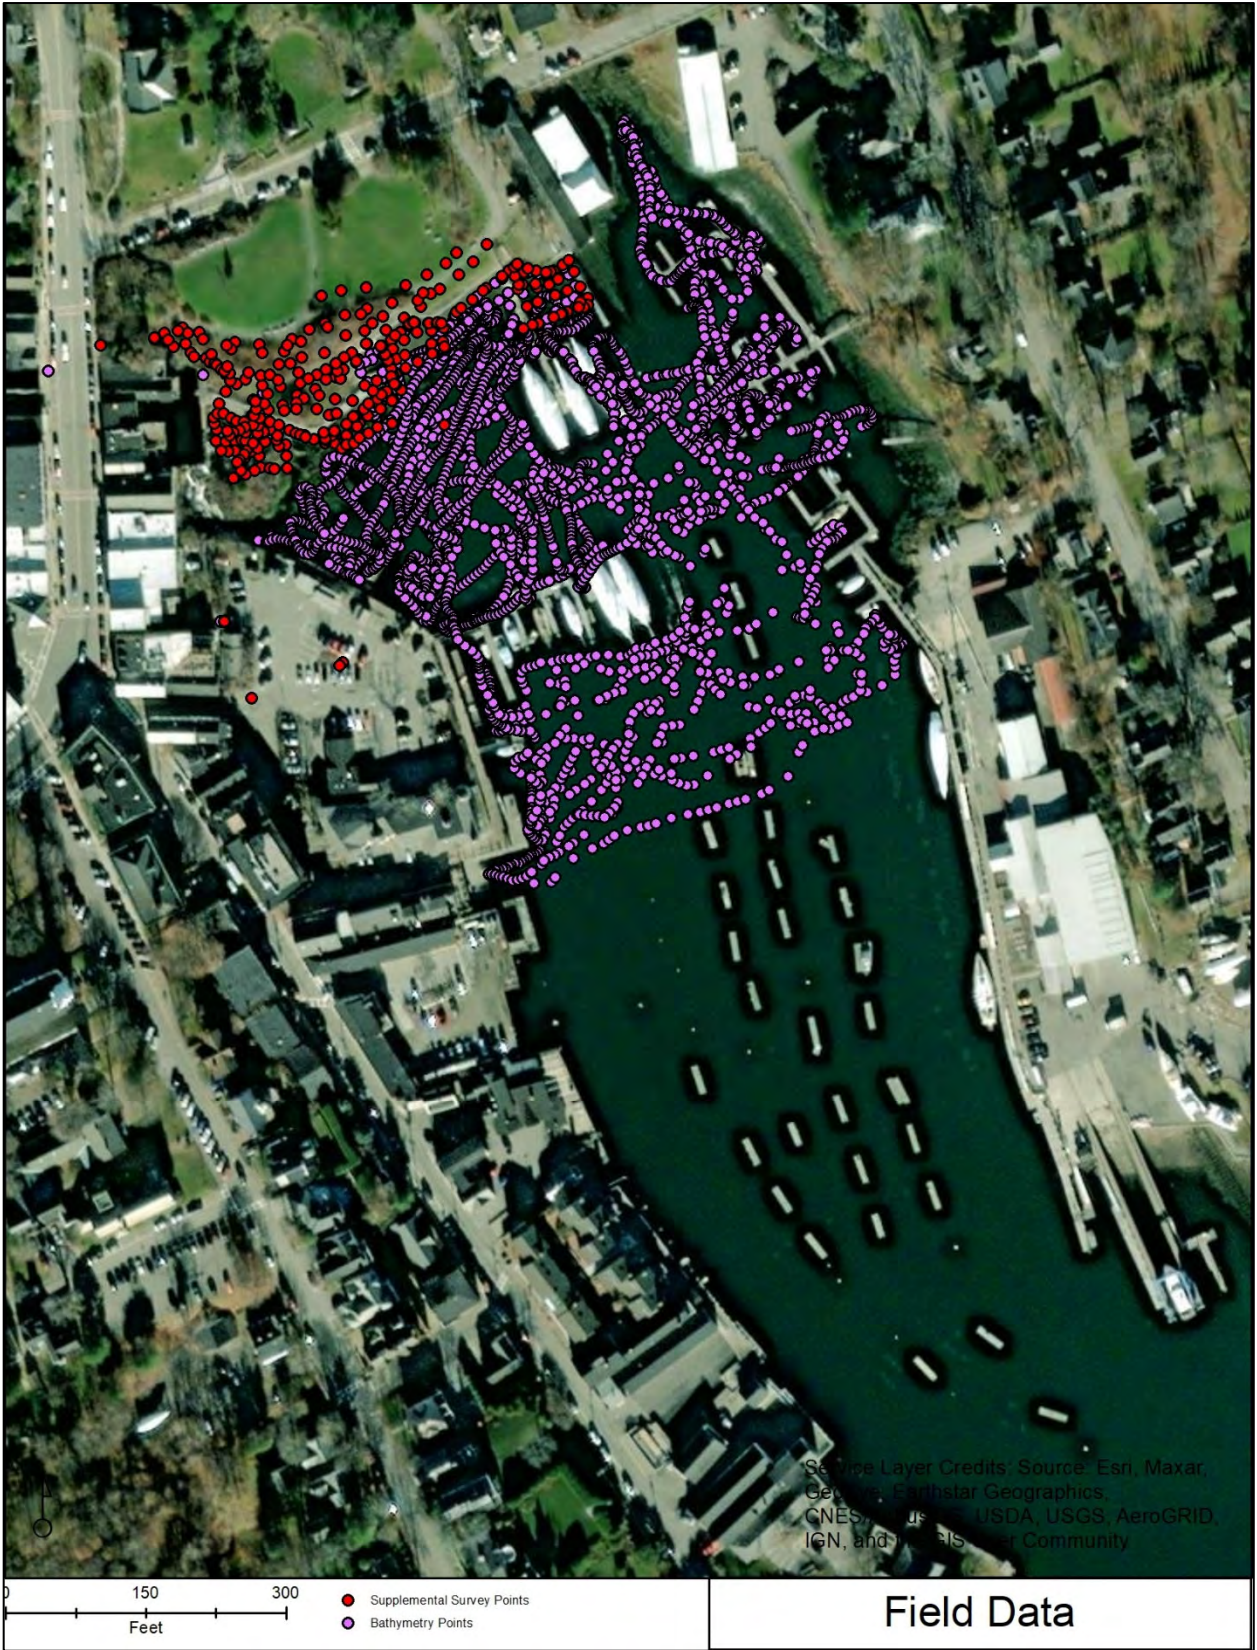
Figure 1. Distribution of bathymetric and supplemental terrain survey points.

- Bathymetric survey of the Camden Inner Harbor – This survey was conducted by Inter-Fluve staff using a remote unmanned aquatic vessel deployed with a single beam echosounder. The survey covered the area of the harbor immediately adjacent to the outlet of the Megunticook River. The distribution of bathymetric data points is shown in Figure 1. This data was integrated into the project existing terrain surface elevation model shown in Figure 16.

- Supplemental Survey in the Project Area - This one-half day survey was conducted by Inter-Fluve staff on March 17, 2020 using real time kinematic differential GPS equipment. This survey collected the locations and ground elevations of the subsurface boring locations, near shore areas that were too shallow for bathymetric survey, and exposed bedrock locations downstream of the dam, adjacent to the gate outflow and sea wall. The distribution of terrain data points is shown in Figure 1. This data was integrated into the project existing terrain surface elevation model shown in Figure 16.

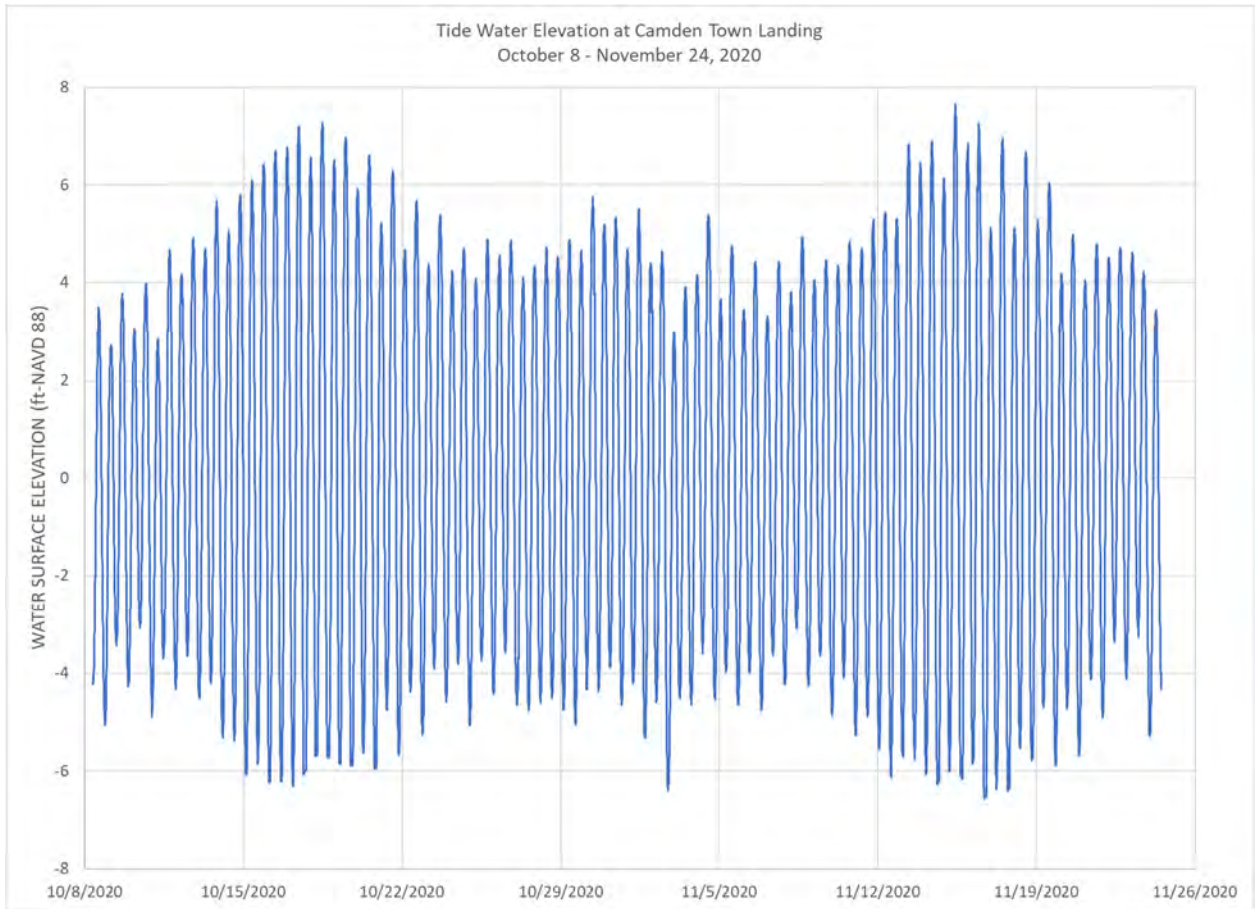
Figure 2. Tidal water surface elevation October 8 to November 26, 2000 in Camden Harbor near the Town landing.

- Tidal water level data collection – While not initially included in the project scope, tidal water level at one location adjacent to the public landing was monitored from October 8 to November 24, 2020. This data was collected to establish tidal water level boundary conditions for the harbor modeling discussed later in this summary. The collected tidal data is shown in Figure 2, and the associated calculated tidal datums over the data collection period are summarized in Table 1.

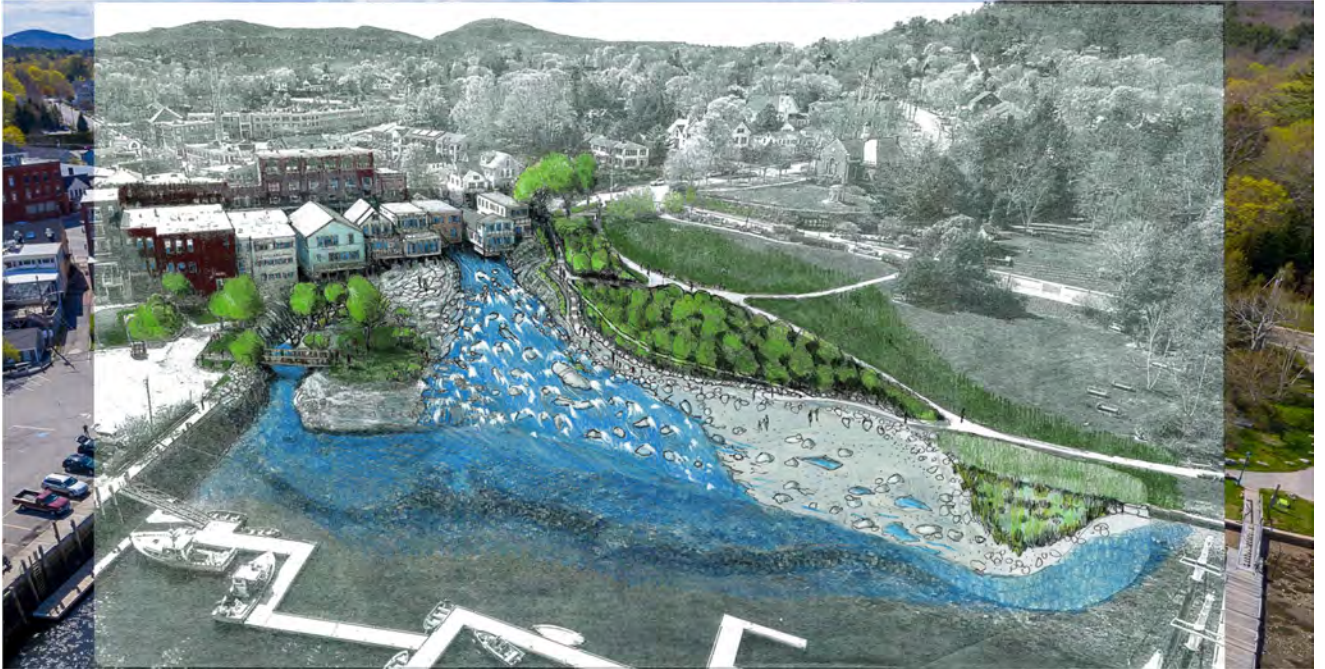
Figure 3. Conceptual rendering of the basic Montgomery Dam dam removal case at high river flow and mean tide level.

- Task 3.3: Conceptual Design Layout
 - Synopsis: Work was completed in 2020 for the project option suggested by Town (dam removal with river restoration). This work primarily entailed engineering development of a conceptual schematic design layout that advanced the preliminary schematic included in the Montgomery Dam feasibility study, in order to support development of conceptual renderings. The conceptual design development integrated the results of the subsurface exploration and exposed bedrock surveys. Schematic layout drawings are included in Appendix B.
- Task 3.4: Landscape Renderings
 - Synopsis: Based on the suggested project alternative identified by the Town, in addition to a basic dam removal alternative, a series of illustrative renderings were prepared. Working sketches were also produced. Illustrative drawings are shown in Figure 3 to Figure 8.

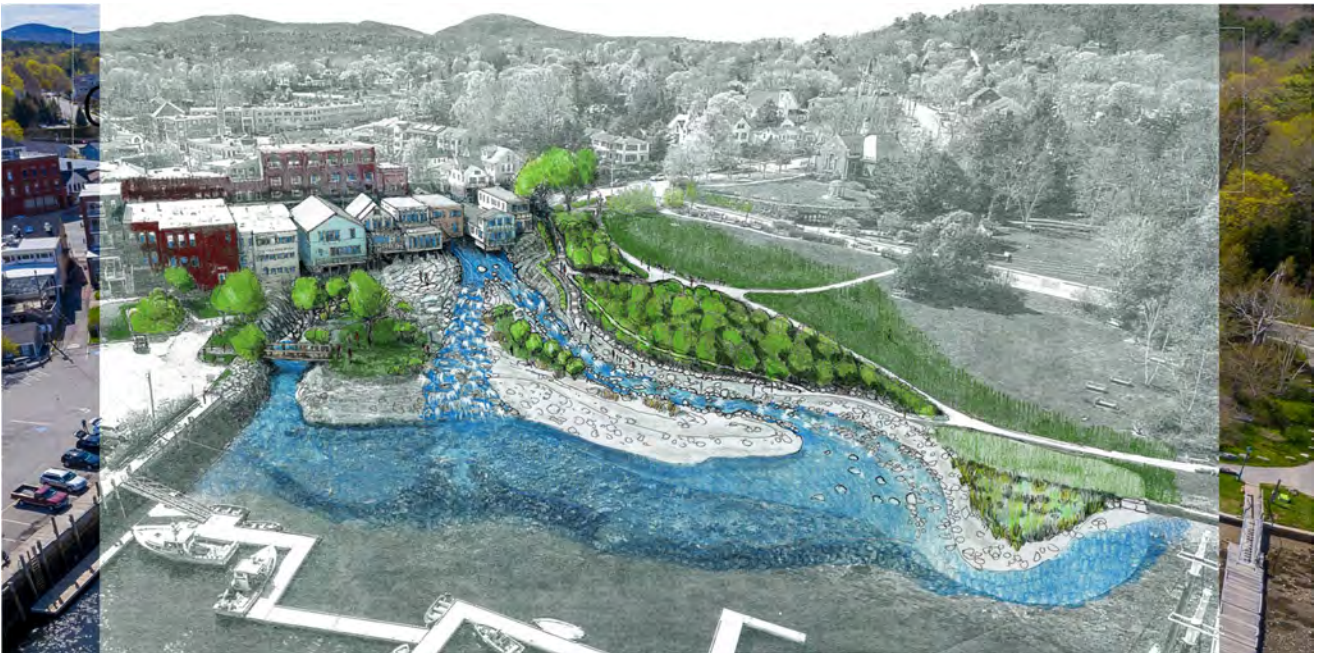
Figure 4. Conceptual rendering of the Montgomery Dam dam removal case with restored channel alignment at high river flow and mean tide level.

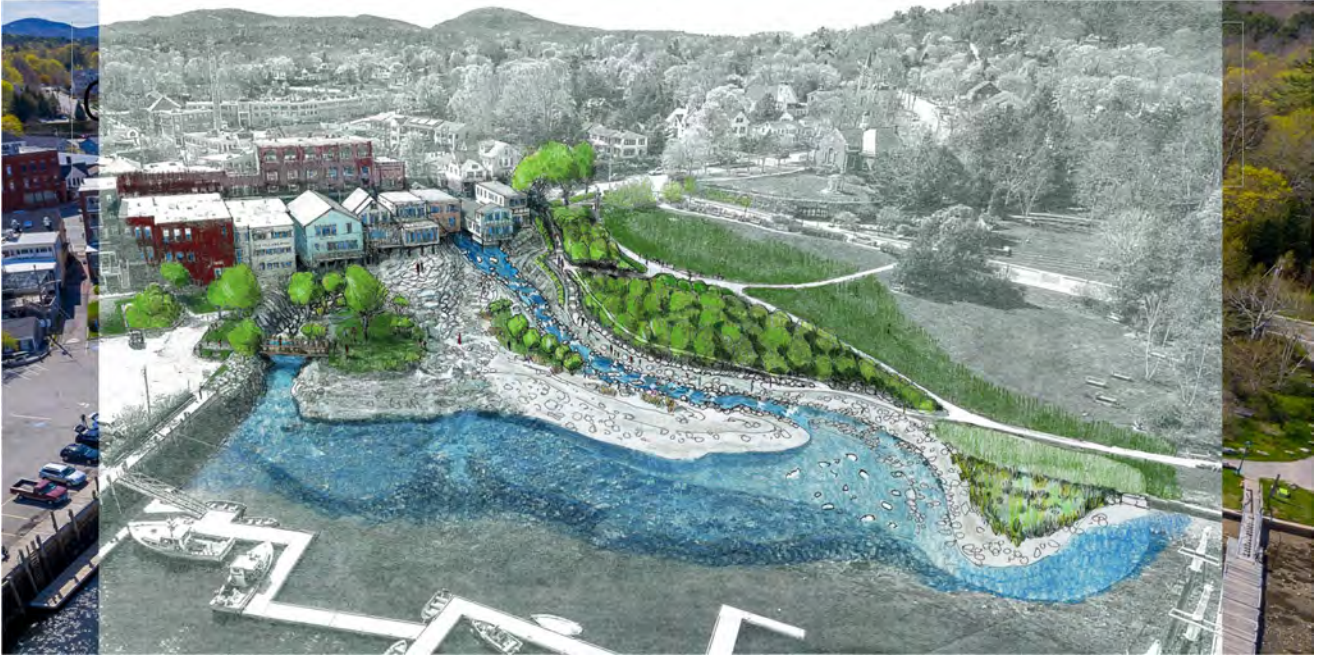
Figure 5. Conceptual rendering of the Montgomery Dam dam removal case with restored channel alignment at low river flow and mean tide level.

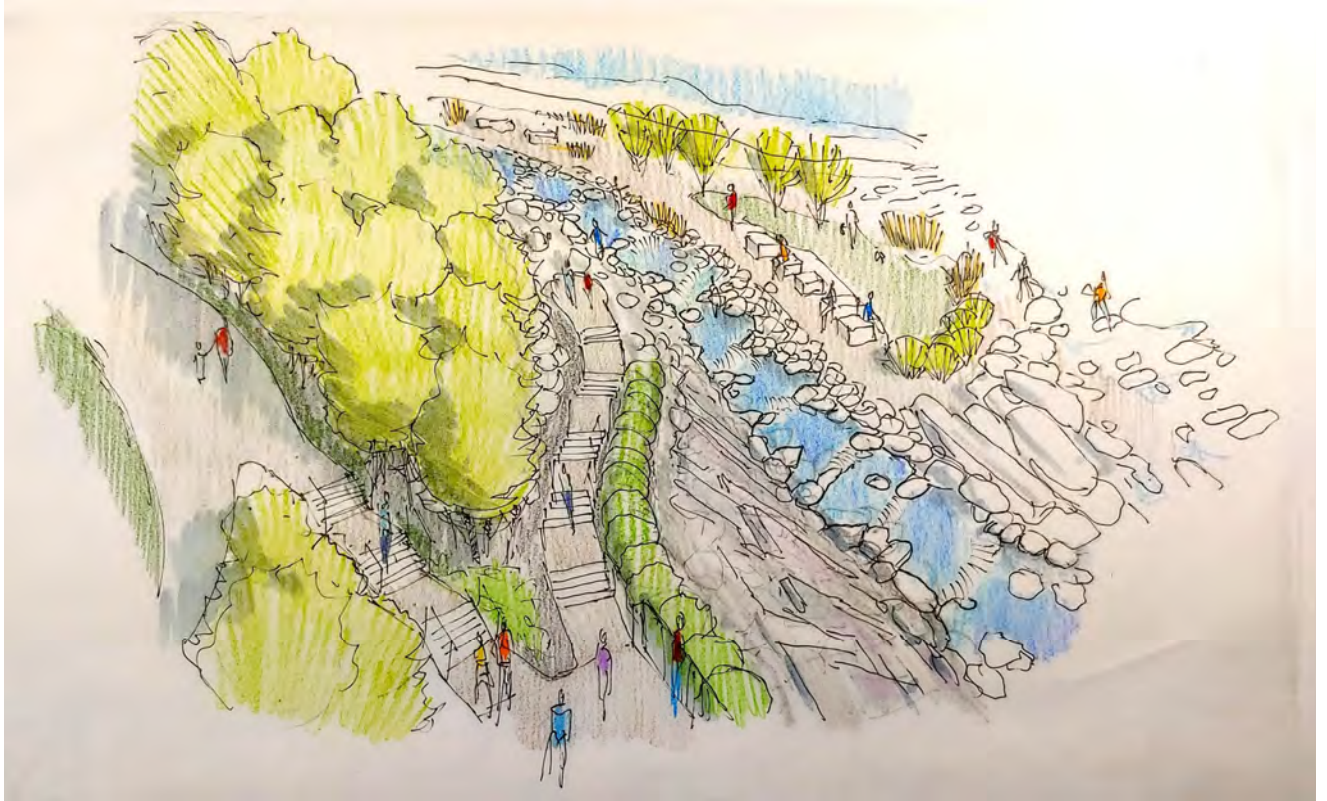
Figure 7. Conceptual perspective view of the Montgomery Dam dam removal case with restored channel alignment.

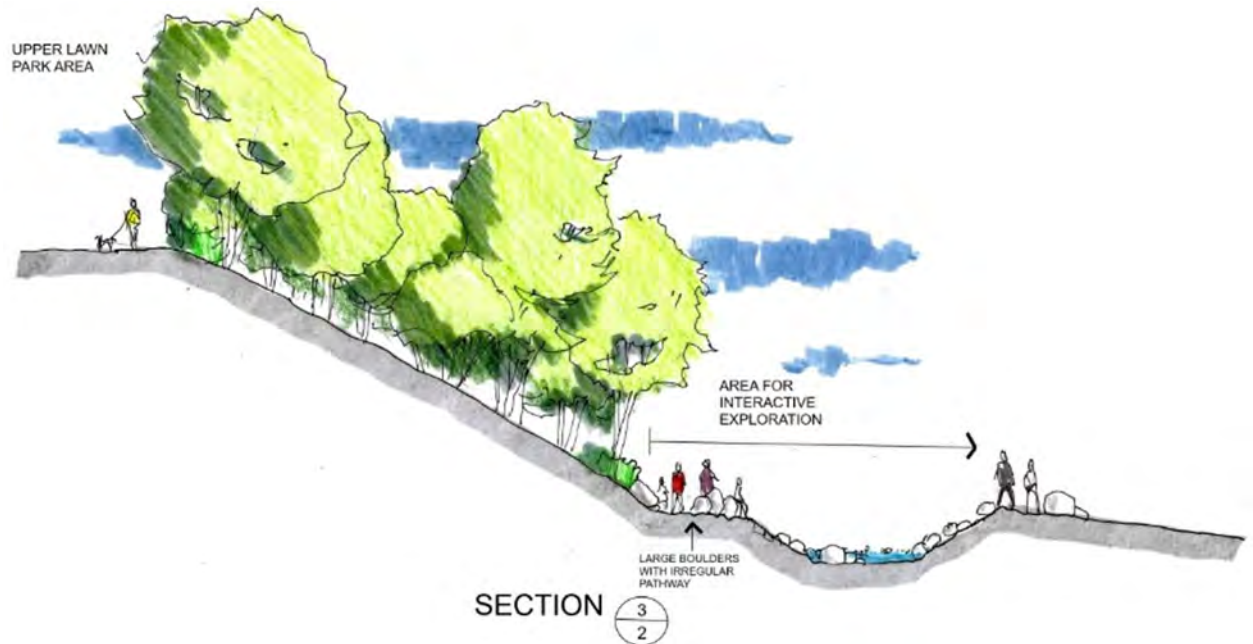
Figure 8. Conceptual section view of the Montgomery Dam dam removal case with restored channel alignment.

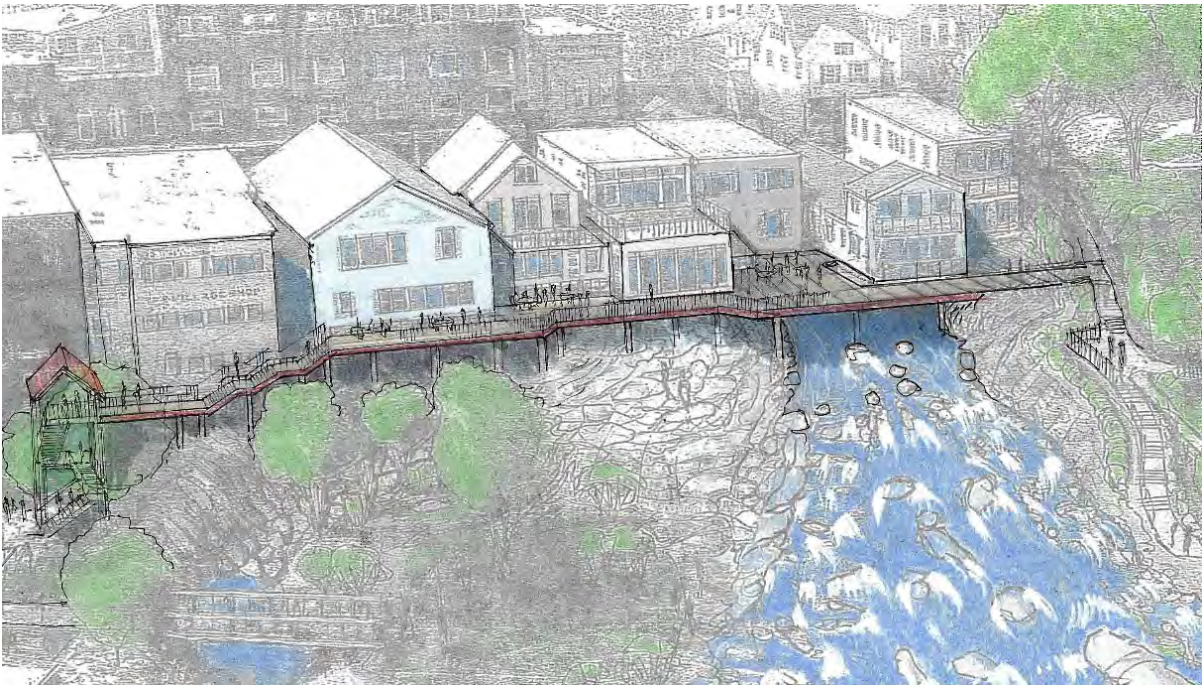
Figure 9. Conceptual perspective sketch of a boardwalk option behind Main Street buildings.

- Task 3.5: Structural Consultation & Design
 - Synopsis: The primary activity under this sub-task was an evaluation of options to provide screening behind the buildings that hover over the Montgomery Dam impoundment, which included boardwalk, screening, building extension, and structural element improvements. The summary report for this task order is found in Appendix C. Illustrative sketches for these options were also created, shown in Figure 9 to Figure 12.

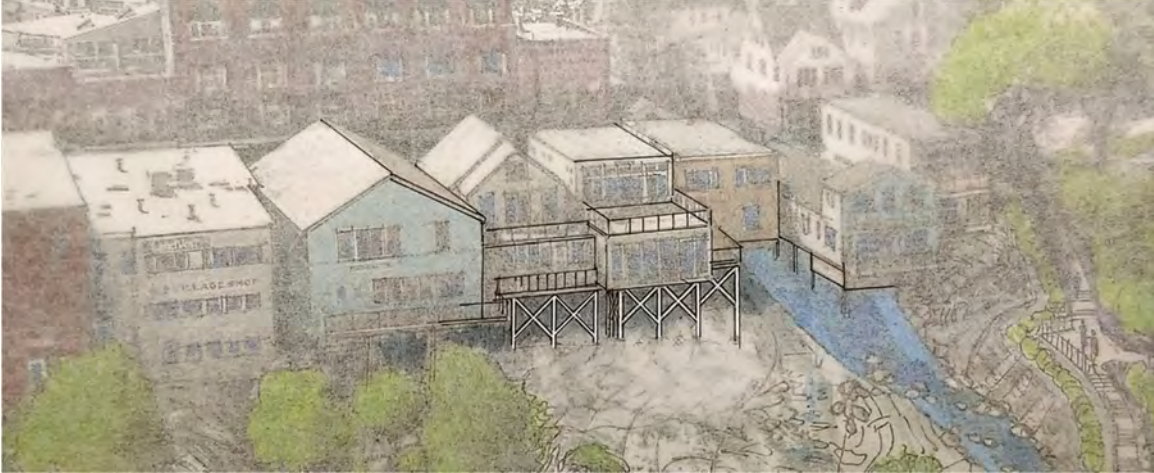
Figure 12. Conceptual perspective sketch of a structural element consistency upgrade option behind Main Street buildings.

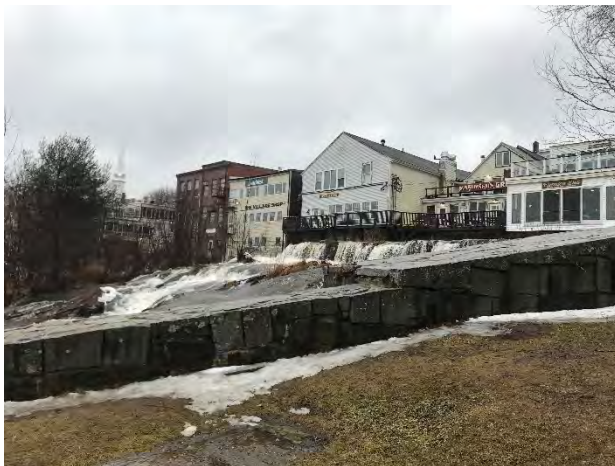
Montgomery Dam Spillway

Montgomery Dam is located at the outlet of the Megunticook River flowing to Camden Harbor. The current dam structure is constructed of quarry rock with a small upstream impoundment. The dam is 100 feet in length bearing upon bedrock with a spillway elevation of 24.4 feet.

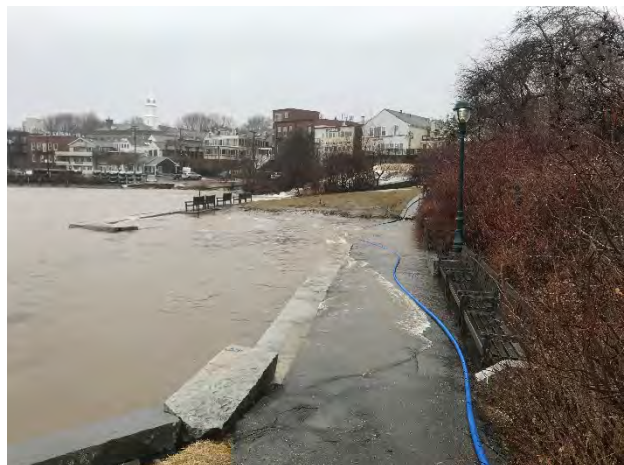
Lower Harbor Park (High Tide)

At high tide, the lower portion of Harbor Park was observed as being partially submerged along the lower paved walkway. Photograph was taken on February 27, 2020 at 12:40 pm near the peak of high tide listed at 1:16 pm by US Harbors tide chart for Camden, Maine.

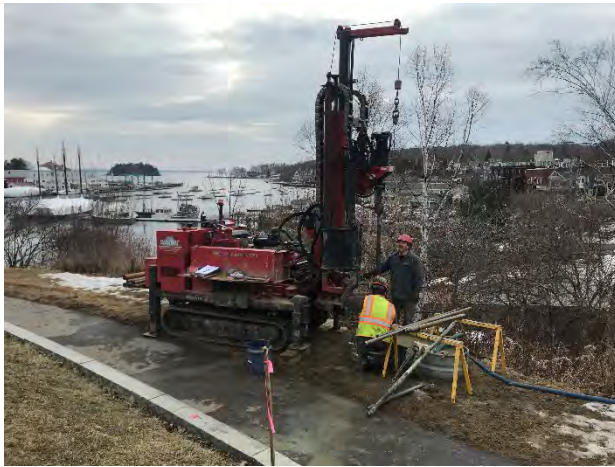
Test Boring B-1 (Rotary Wash)

Summit Geoengineering Services, Inc. (SGS) observed the subsurface conditions with the drilling of 8 test borings on February 26 to 27, 2020. Test borings were performed using a track mounted AMS Power Probe 9500 VTR. Test borings were advanced using 3.5-inch outer diameter drill casing with rotary wash by roller cone to depths of refusal ranging from 5.0 to 24.8 feet below ground surface. Soils were investigated with split spoon sampling using the standard penetration test with an auto drop hammer. Samples were visually logged onsite by a geotechnical engineer using the Unified Soil Classification System (USCS). Test boring locations are shown on the Exploration Plan in Appendix A. Interpretive cross sections are also provided in Appendix A. Logs of the test borings are provided in Appendix B.

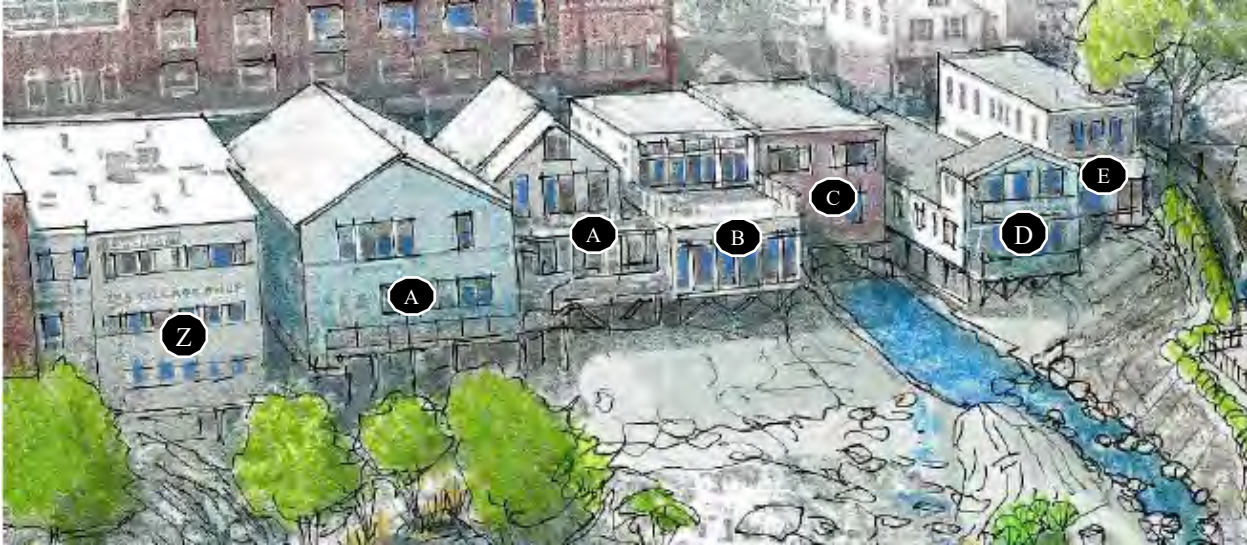
The feasibility report pertains to the following buildings (or appurtenances to these buildings):

- Ⓐ 35 Main Street (Marriner’s Restaurant, Once a Tree)
- Ⓑ 37 Main Street (Camden Deli)
- Ⓒ 39 Main Street (Surroundings)
- Ⓓ 41 Main Street (The Smiling Cow)
- Ⓔ 43 Main Street (Psychic & Tarot)
- Ⓕ 25 Main Street (The Village Shop)
